Simulation of the Dynamics of the Fire at 3146 Cherry Road NE Washington D.C., May 30, 1999

Daniel Madrzykowski Robert L. Vettori

April 2000

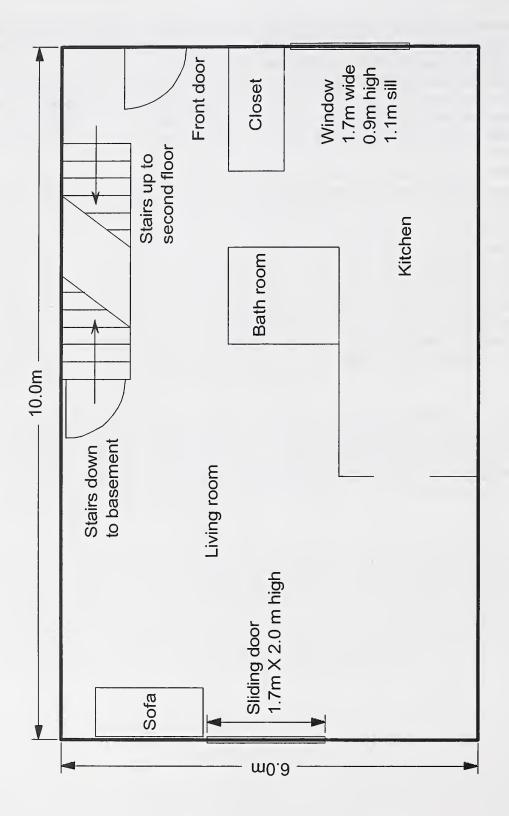
Figure 1. Plan view of first floor.

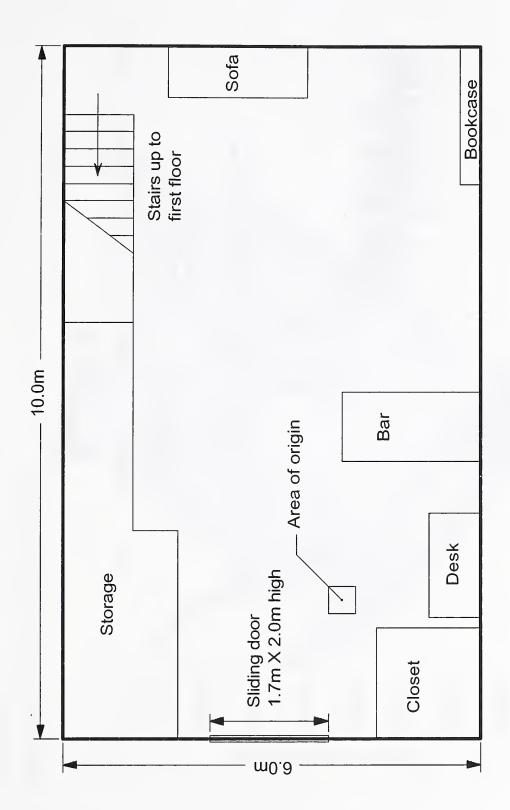
Figure 2. Plan view of basement.

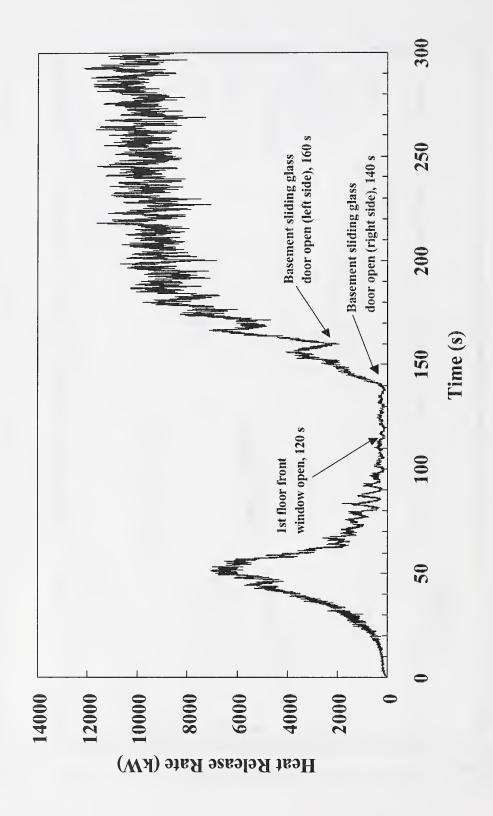
Figure 3. Heat release rate from FDS Simulation.

A time history of the fire's heat release rate, as predicted by FDS, is shown in Figure 3. Annotations on the figure highlight the venting activities and the resulting impact on the development of the fire. As shown in the graph, venting the basement results in a heat release rate increase of more than 10,000 kW or 10 MW within approximately one minute.

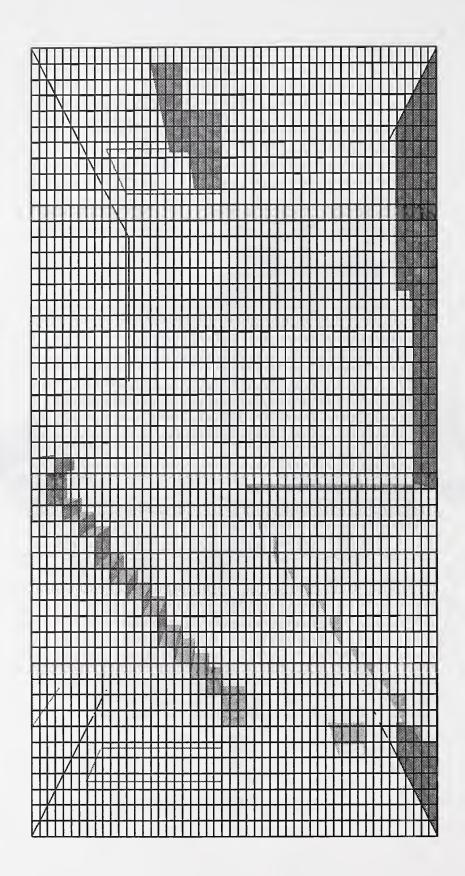
Figure 5. Grid layout in the xz plane.

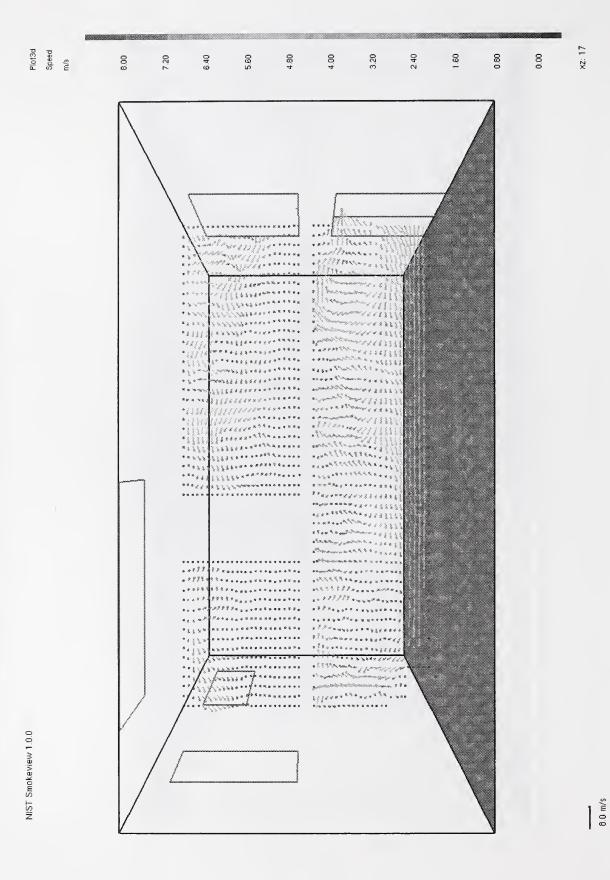
Figure 7. Vector representation of velocity slice along basement sliding glass door, at 200 seconds of simulation.

Figures 6 and 7 show the plane of temperatures and velocities that align with the center of the first sliding glass panel that was taken out on the basement level. This plane is located 3.4 m (11.2 ft) into the townhouse from the front of Figures 6 and 7. The upper portions of the figures represent the kitchen area on the left and the living room area on the right. In Figure 6, temperatures in excess of 820 °C (1500 °F) are shown throughout the basement, with the exception of the cool air entering the basement through the open sliding glass doorway at the right of the figure. Similar hot gas temperature conditions exist in the living room area. The maximum temperatures in the kitchen are in the 500 °C to 660 °C (932 °F to 1220 °F) range. The velocity vector plot in Figure 7 provides gas flow direction as well as the approximate velocities. The dominant flows in this plane are the fresh air entering the open basement doorway at approximately 4 m/s (10 mph) and the hot gas flow exiting the upper portion of the doorway at approximately 7 m/s (16 mph).

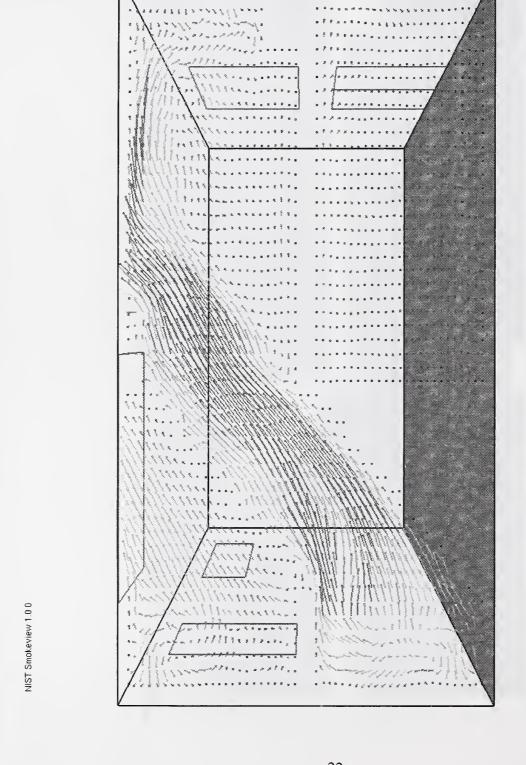
Figure 11. Vector representation of velocity along centerline of stairway, at 200 seconds of simulation.

Figure 11 shows the effect of the stairway on channeling the hot gases up to the first floor. The speed at which the fire gases flow up the stairway and across the ceiling of the first floor exceed 8 m/s (18 mph). At these velocities, the travel time for the gases from the front of the basement (left side of figure) to the back of the first floor (right side of figure) is less than 2 s. Between the doorway to the basement and the sofa, the velocities from approximately 0.5 m (1.6 ft) above the floor to floor level are in the range of 0 m/s to 1.6 m/s (0 mph to 3.5 mph). The right side of the basement shown is the storage area under the stairs.

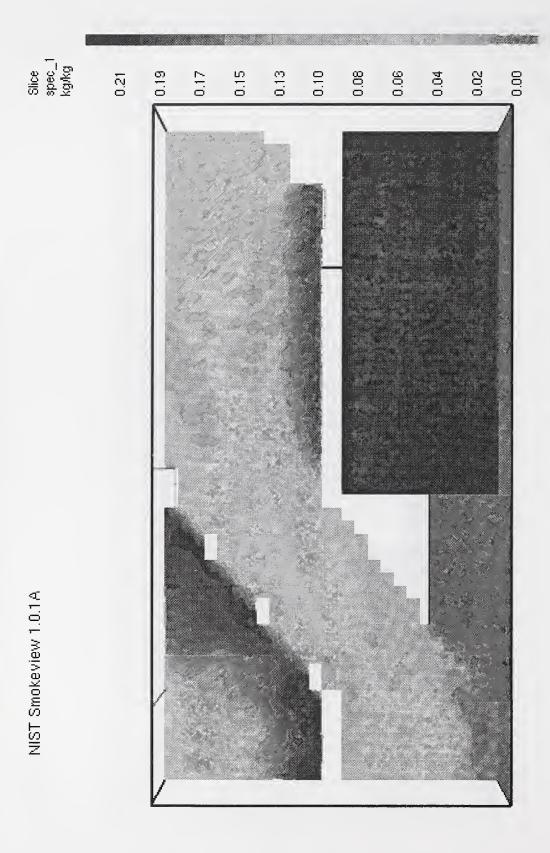
Figure 13. Percent oxygen along centerline of stairway, at 200 seconds of simulation.

Figure 13 gives a view of the oxygen conditions along the centerline of the basement stairway. The hot gases that are flowing up from the basement are oxygen depleted, ranging from 14 % to 16 % oxygen at the base of the stairs and decreasing to 6 % to 11 % oxygen at the top of the stairs. The high velocity hot gas layer that flows across the living room ceiling and down the back wall of the townhouse (right side of figure) contains less than 6 % oxygen. Given the oxygen depleted conditions, little if any flaming combustion would be taking place in the living room area at this time. The right portion of the basement represents the storage area under the steps.

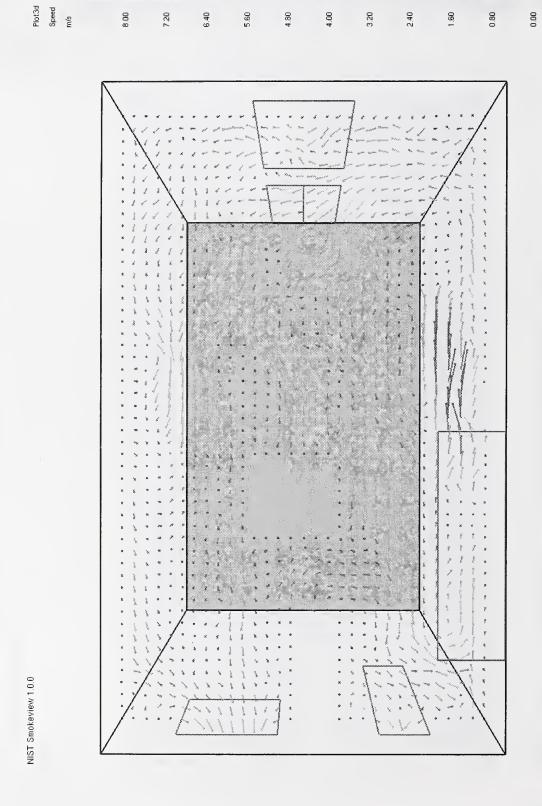
Figure 15. Vector representation of velocity at first floor window, 1.6 m off the floor, at 200 seconds of simulation.

Figures 14 and 15 show the velocity flow patterns near the ceiling of the first floor and at approximately 1.6 m (5.2 ft) above the floor, respectively. The velocities in front of the doorway to the basement are in the range of 8 m/s (18 mph). Figure 15 shows the circulation of gases from the doorway to the basement, across the back wall of the townhouse and then out the front window. Velocities flowing through the house in this U– shaped pattern range from 0.80 m/s to 4.8 m/s (2 mph to 11 mph) at this level. These velocities coupled with the high gas temperatures will increase the rate of convective heat transfer to people or objects in that area.

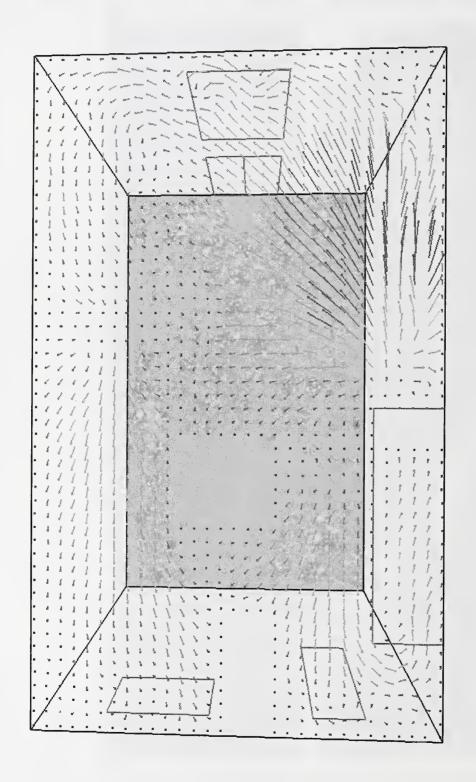
Figure 17. Vector representation of velocity at the ceiling with first floor sliding glass door vented, at 200 seconds of simulation.

Figure 17 shows the velocity field at the ceiling of the first floor. Comparing this to Figure 14 shows that the velocity range is similar, approximately 8.5 m/s (19 mph) vs. 8 m/s (18 mph). The flow pattern at the ceiling is wider for the second simulation because part of the flow stream is going out of the open sliding glass doorway.
